The Bootlin ~~War stories~~ Debugging Chronicles

Embedded Recipes 2026

This talk

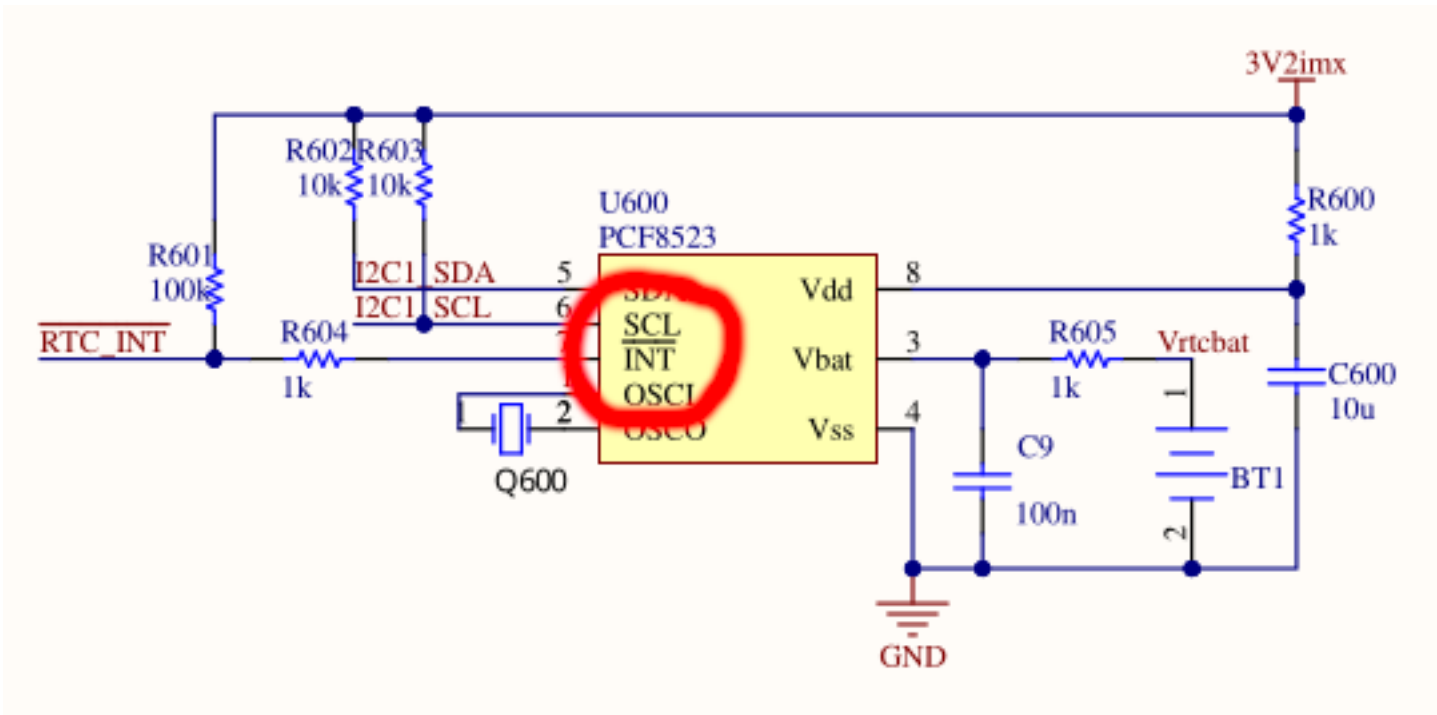
OK, schematics now!

- ▶ A very simple CPU-bound application is indeed $\approx 2x$ slower
- ▶ What else is using the CPU?
 - `top` doesn't show anything suspicious: no other process is obviously hogging the CPU
- ▶ If nothing is hogging the CPU, is the CPU running at a lower frequency?
 - `cpufreq` seems to be configured / working correctly
 - Switching to the `performance` governor doesn't make any difference
- ▶ So there must be something else hogging the CPU
 - Interrupts?
 - `watch -n1 cat /proc/interrupts`
 - And indeed, one interrupt line has **10000s** of interrupts per second on the “slow” SoMs, while the “fast” SoMs are not affected
 - This interrupt line is a GPIO interrupt

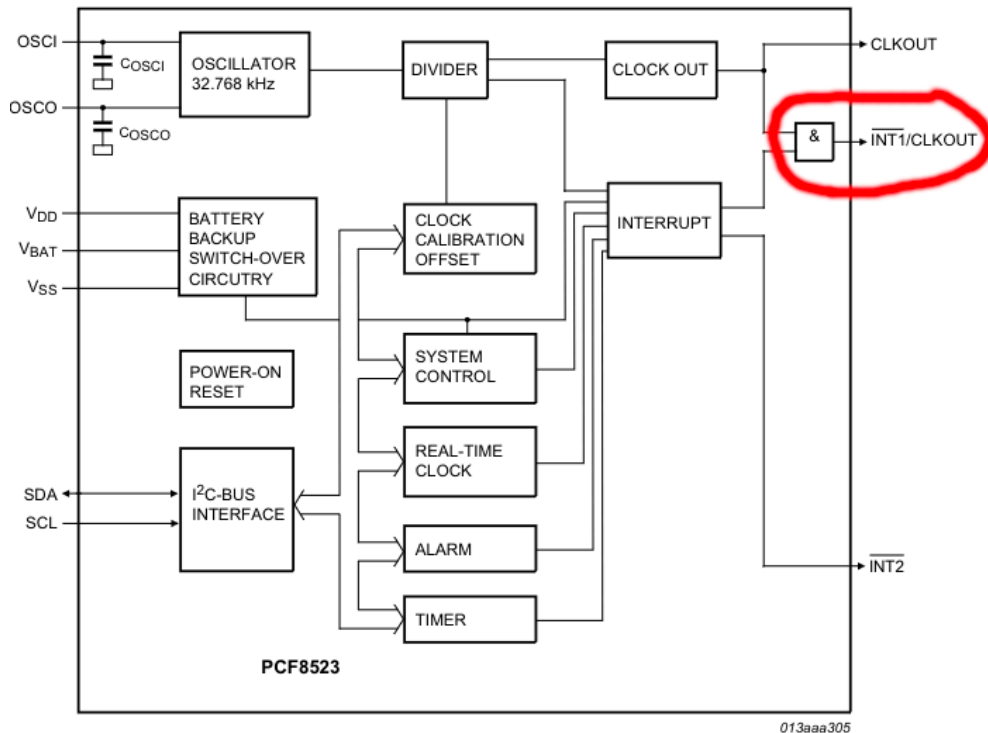
RTC interrupt

- ▶ So the RTC is hammering us with **10000s** of interrupts per second
- ▶ How does that even make sense?
- ▶ RTC datasheet to the rescue

- ▶ So, perhaps we're not getting hammered by interrupts but by the clock generator?

- ▶ Ah, ah, out of reset, CLKOUT is **active**, at 32,768 Hz, nicely matches the number of interrupts we're seeing!
- ▶ But then why are some SoMs getting hammered by this clock signal and not others?

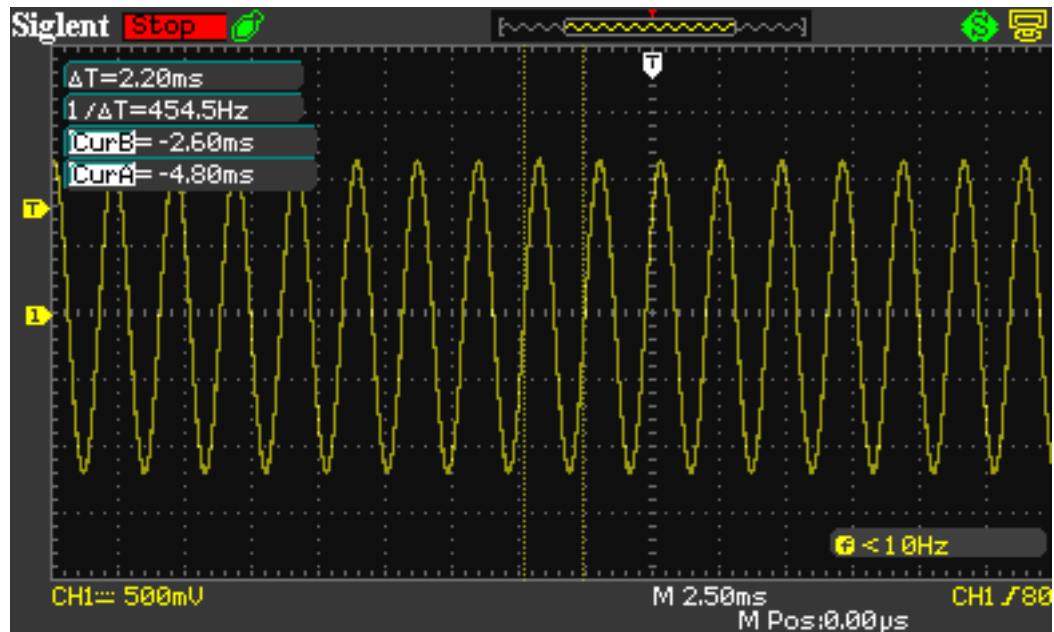
- ▶ The analog output was perfectly fine:

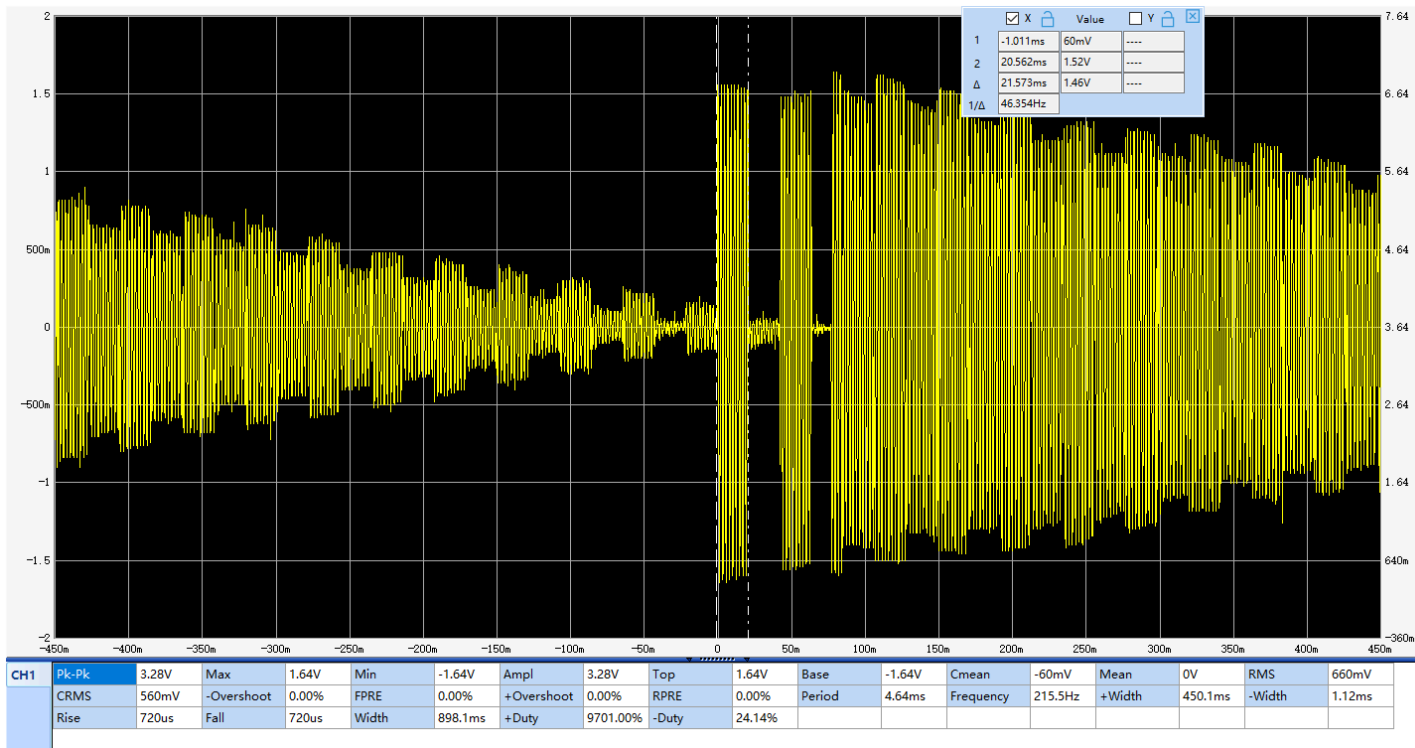
- ▶ To get more visibility on the FIFO content, an audio file has been crafted: a fading out 440 sine wave.

- ▶ Here it is, the issue is that the periods (20ms of samples here) are not played in order.
- ▶ This is definitely observable on the PCM bus
- ▶ But the file and the userspace buffers are correct
- ▶ \Rightarrow DMA is the culprit
- ▶ But the transfers are happening regularly, they have the correct size and run for the proper duration.

- ▶ Multiple SDMA firmwares were tested without any luck.
- ▶ Backporting board support on 4.1.35 fixed the issue but this was not satisfying
- ▶ The culprit was 5881826ded79 (“dmaengine: imx-sdma - update the residue calculation for cyclic channels”) that appeared in v4.9
- ▶ Final fix is 85f57752b33c (“dmaengine: imx-sdma - correct the dma transfer residue calculation”) in v4.10
