The Bootlin ~~War stories~~ Debugging Chronicles

Embedded Recipes 2026

This talk

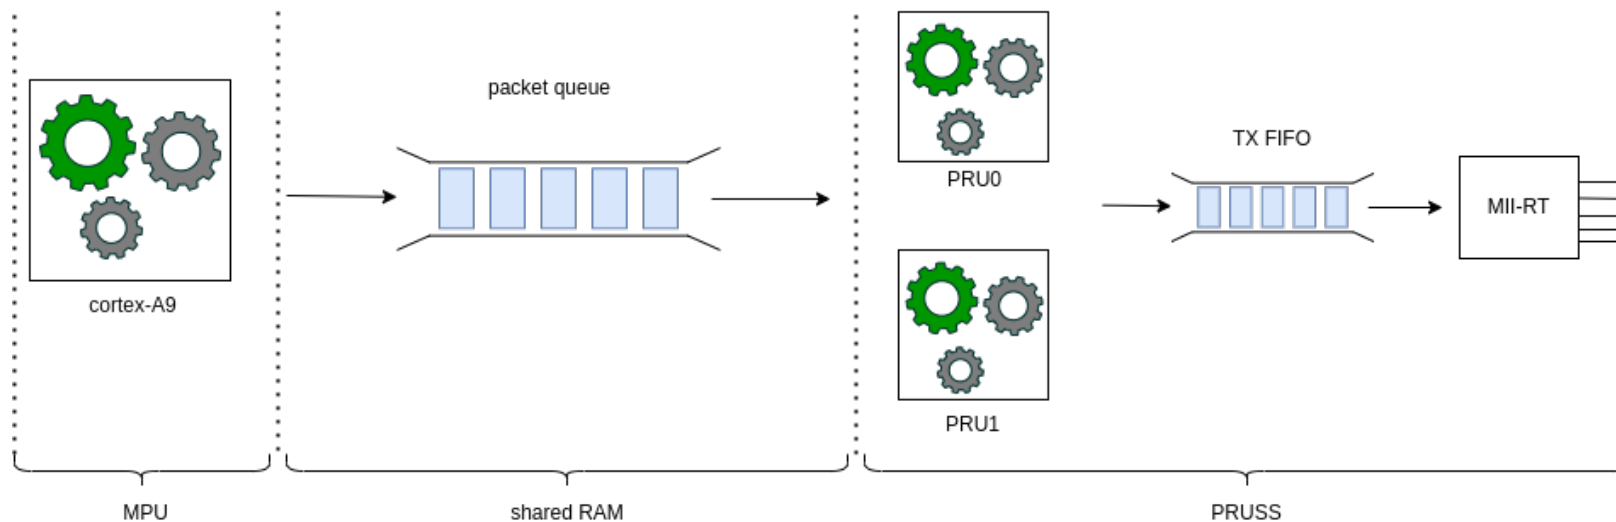
- ▶ Customer had a product based on an AM437x SoM
- ▶ Malformed packets were observed on a PRU Ethernet interface

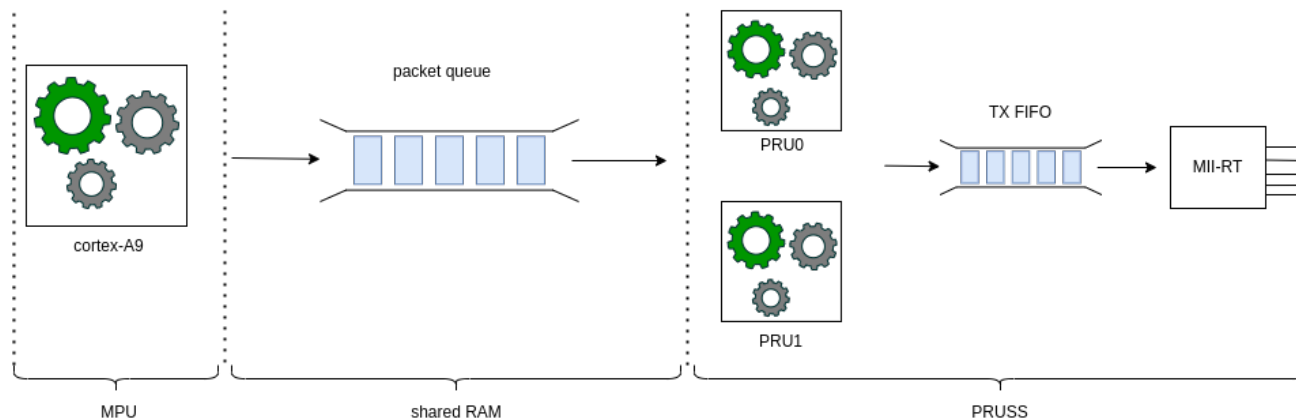
- ▶ Reproduced the issue and characterized it further
- ▶ As it turns out, packets under a certain size were truncated and resent multiple times
- ▶ Initial troubleshooting ruled out a bug in the Ethernet driver

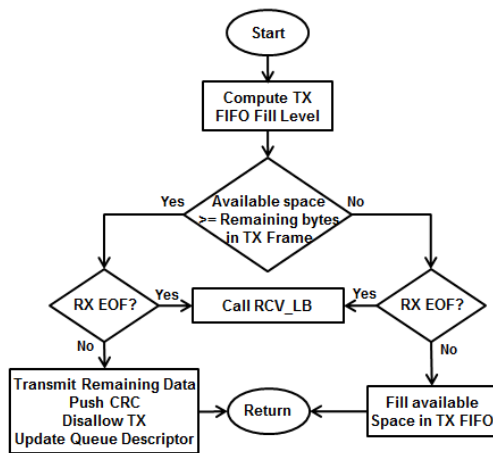
- ▶ Checked control flow in PRU firmware
- ▶ Found some strange TX FIFO overflow events

- ▶ Turns out there was a bug in the code computing the TX FIFO fill level

```
--- emac_MII_Xmt.asm
+++ emac_MII_Xmt.asm
@@ -915,6 +915,13 @@ XMT_LB_100Mbps_MODE:
    ;Detect FIFO overflow and reset
    .if $defined("ICSS_REV1")
+
+   .if $defined("PRU0")
+       LBC0          &TEMP_REG_3, IEP_CONST, CAP_RISE_TX_SOF_PORT1_OFFSET, 4
+   .else
+       LBC0          &TEMP_REG_3, IEP_CONST, CAP_RISE_TX_SOF_PORT2_OFFSET, 4
+   .endif
+
    M_XMT_FILL_LEVEL_CALC_ICSS_REV1          ;calculates Fill level and
resets in case of underflow/overflow
    .endif
```

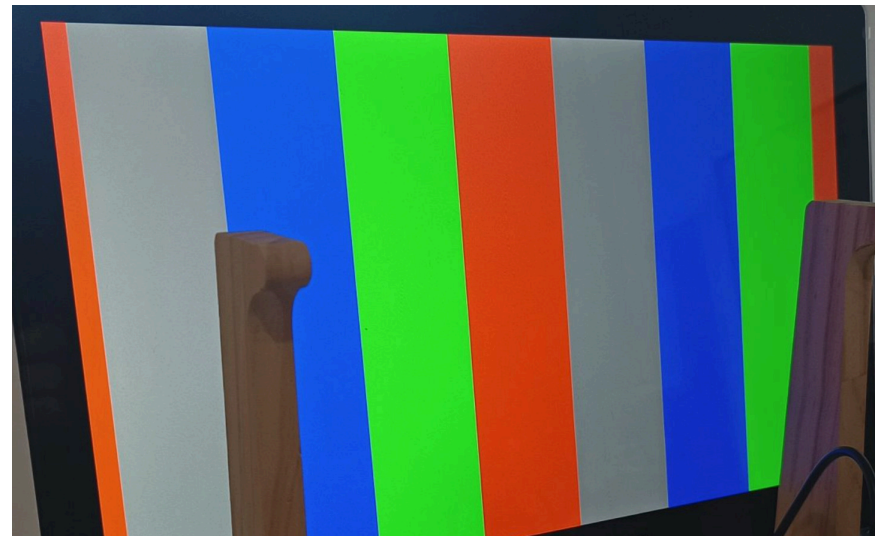
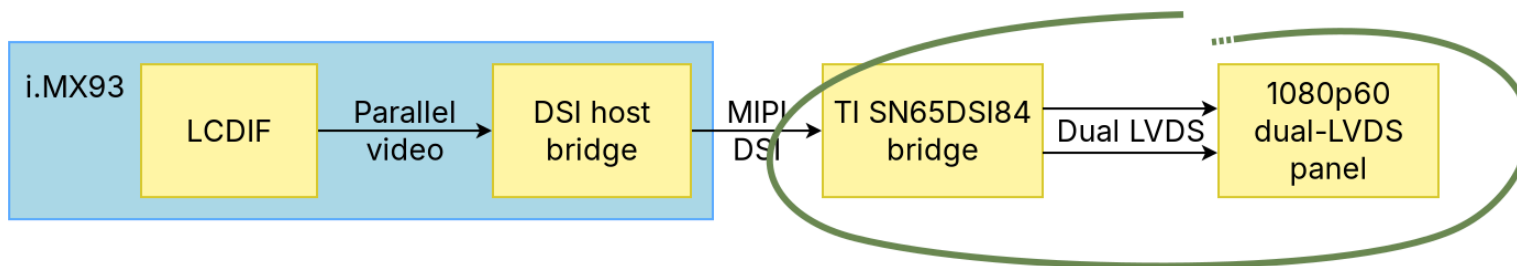
- ▶ DSI-Tuner has lots of parameters, not all obvious
- ▶ But after some attempts...
- ▶ Test pattern working!

- ▶ But disabling test pattern, still a black screen ☹️

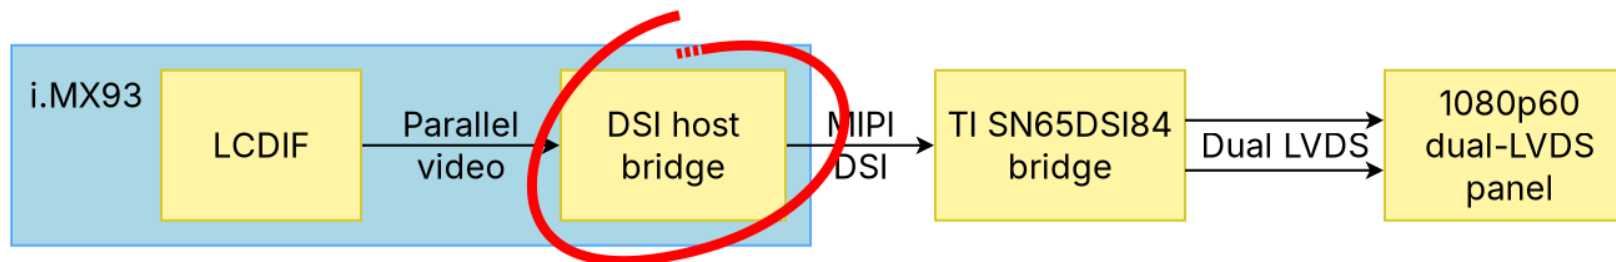
- ▶ Read docs
- ▶ Check all registers
- ▶ Enable test pattern (already implemented by driver)
- ▶ Check all the clocks (again)
 - All pixel-related clocks have correct values with good margin
 - All data busses have a clock fast enough for the needed bandwidth, with large margin
- ▶ The “DPI Payload Write Error” bit goes high
 - Suggests the DSI host is unable to buffer enough data from the LCDIF → underrun
 - Tried increasing the AXI bus clock, but to no avail

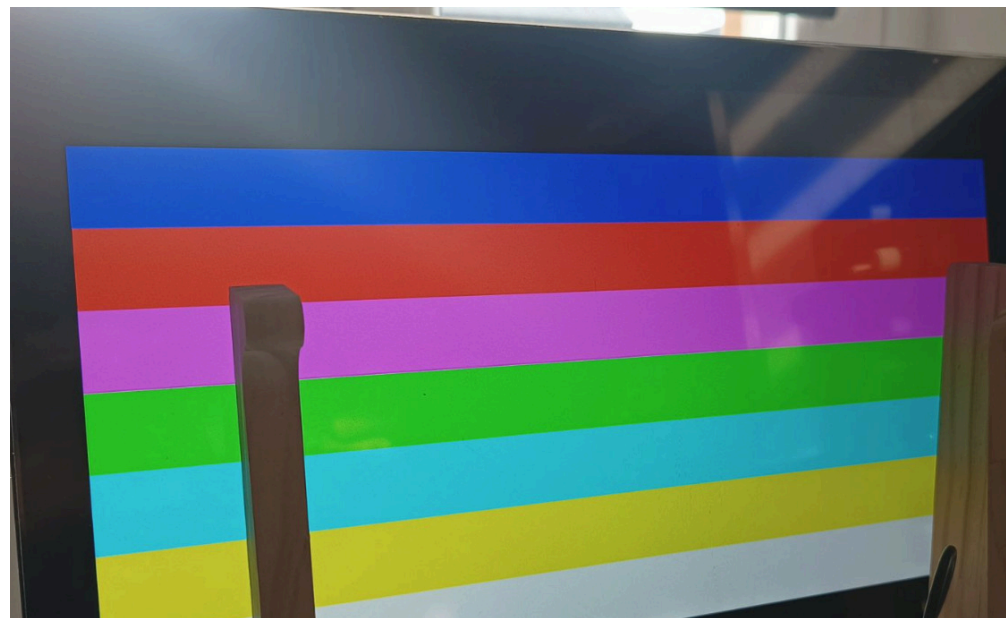
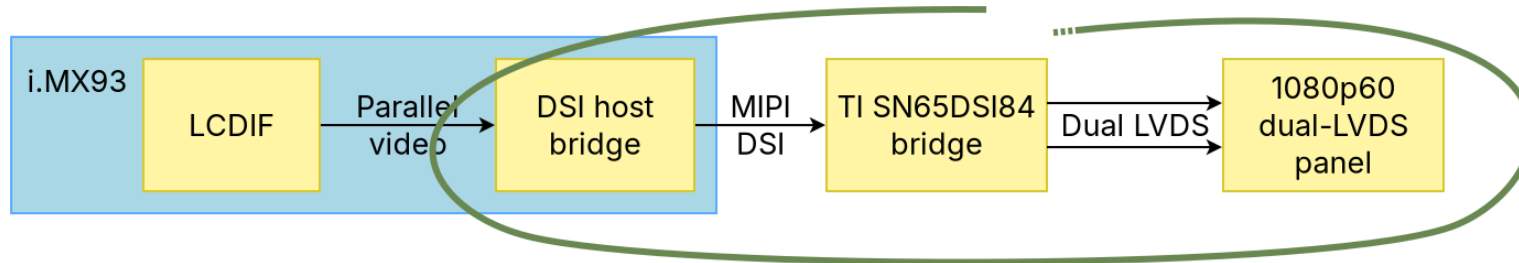
- ▶ Check all the clocks (again²)
- ▶ Many desperate attempts later...
- ▶ Remove `assigned-clock-rates` from the board device tree
- ▶ DSI host test pattern appeared!

- ▶ Take a deep breath...
- ▶ Examine the removed `assigned-clock-rates` one by one
`assigned-clock-rates = <437100000>, <142380000>, <400000000>, <133333333>;`
 - `nic_media` clock increased from 400 MHz to 800 MHz
 - But it causes the kernel hang! → change reverted
 - Pixel clock got *very slightly* more accurate
 - This *is* actually relevant! → change kept
